# Asbestos Refurbishment Survey

## Mairangi Bay School, Galaxy Dr, Mairangi Bay, Auckland 0630

Field Work Date: 28/02/2019, 13/03/2019  
Report Submitted: 08/03/2019  
Release/Version date:

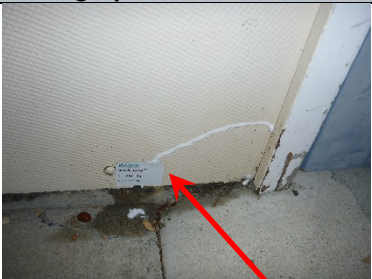
Identification		Location		Hazard Identification			Photograph
S101276	Building	5-8	Hazard Group	Asbestos	Laboratory Sample number	1 Cert No: B-19-0254

Floor(s)	Ground	Area	>50m2	Sample result	Chrysotile (White asbestos), Amosite (Brown/Grey asbestos), Crocidolite (Blue asbestos)	
			Product Type	1			
	Nature of site	Classroom	Extent of damage	1	Labelled?	No	
	Int/Ext	Exterior	Surface Treatment	1	Re-inspection date	TBA	
	Room	5-8	Potential to release fibres	3 - Low			
Location	North and south side of building - walls			Recommendation	Remove all cement sheeting and downpipes as Class B work in accordance with the Approved Code of Practice.  All panels that remain are to be kept painted and their existence noted on the school's management plan.		
Description	Cement sheeting

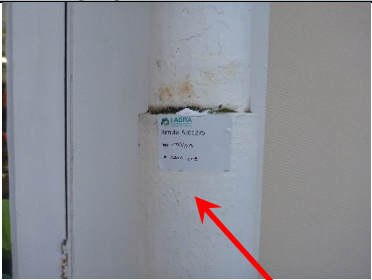
Identification	Location		Hazard Identification				Photograph
S101275	Building	5-8	Hazard Group	Asbestos	Laboratory Sample number	2 Cert No: B-19-0254

Floor(s)	Ground	Length	30m	Sample result	Chrysotile (White asbestos), Amosite (Brown/Grey asbestos), Crocidolite (Blue asbestos)	
			Product Type	1			
	Nature of site	School	Extent of damage	1	Labelled?	No	
	Int/Ext	Exterior	Surface Treatment	1	Re-inspection date	TBA	
	Room	5-8	Potential to release fibres	3 - Low			
Location	Around building			Recommendation	Remove all cement sheeting and downpipes as Class B work in accordance with the Approved Code of Practice.  All panels that remain are to be kept painted and their existence noted on the school's management plan.		
Description	Cement downpipes.  Note: the pipe extends into the ground, this detail will be replicated for all pipes on the site. Refer S101281.

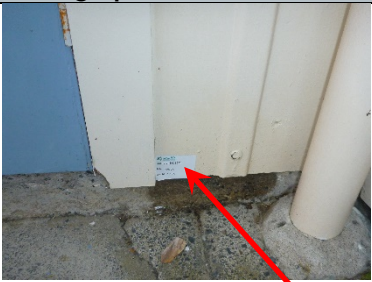
Identification	Location		Hazard Identification				Photograph
	Building	5-8	Hazard Group	Asbestos	Laboratory Sample number	3 Cert No: B-19-0254	
S101274	Floor(s)	Ground	Area	>50m <sup>2</sup>	Sample result	Chrysotile (White asbestos), Amosite (Brown/Grey asbestos), Crocidolite (Blue asbestos)

Product Type	1			
	Nature of site	School	Extent of damage	1	Labelled?	No	
	Int/Ext	Exterior	Surface Treatment	1	Re-inspection date	TBA	
	Room	5-8	Potential to release fibres	3 - Low			
	Location	Located on east, south and west sides of building - walls			Recommendation	Remove all cement sheeting and downpipes as Class B work in accordance with the Approved Code of Practice.	
Description	'Coverline' profiled cement sheeting,			All panels that remain are to be kept painted and their existence noted on the school's management plan.

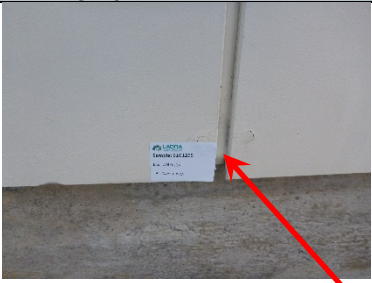
Identification		Location		Hazard Identification			Photograph
S101295	Building	5-8	Hazard Group	Asbestos	Laboratory Sample number	4 Cert No: B-19-0254

Floor(s)	Ground	Area	>50m <sup>2</sup>	Sample result	No asbestos detected	
	Nature of site	School	Product Type	N/A	Labelled?	N/A	
	Int/Ext	Exterior	Extent of damage	N/A	Re-inspection date	N/A	
	Room	5	Surface Treatment	N/A	Potential to release fibres	Nil	
Location	Located on east, south and west sides of building - walls			Recommendation	As there is a mix of asbestos and non-asbestos sheets attached to the building definitive confirmation is needed to confirm that any sheets do not contain asbestos if they are to be treated as non-containing.		
Description	Flat Sheet.

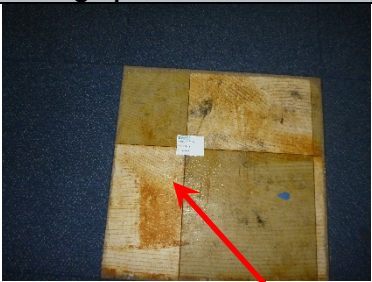
Identification		Location		Hazard Identification			Photograph
S101294	Building	5-8	Hazard Group	Asbestos	Laboratory Sample number	5 Cert No: B-19-0254

Floor(s)	Ground	Area	320m <sup>2</sup>	Sample result	No asbestos detected	
	Nature of site	School	Product Type	N/A	Labelled?	N/A	
	Int/Ext	Interior	Extent of damage	N/A	Re-inspection date	N/A	
	Room	5-8	Surface Treatment	N/A	Potential to release fibres	Nil	
Location	Floor of all rooms			Recommendation	N/A		
Description	Vinyl tiles and adhesive in classrooms

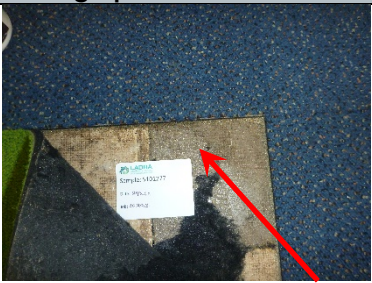
Identification		Location		Hazard Identification			Photograph
S101277	Building	1-4	Hazard Group	Asbestos	Laboratory Sample number	6 Cert No: B-19-0254

Floor(s)	Ground	Area	320m <sup>2</sup>	Sample result	No asbestos detected	
	Nature of site	School	Product Type	N/A	Labelled?	N/A	
	Int/Ext	Interior	Extent of damage	N/A	Re-inspection date	N/A	
	Room	1-4	Surface Treatment	N/A	Potential to release fibres	Nil	
Location	Interior floors Rooms 1-4			Recommendation	N/A		
Description	Vinyl tiles and adhesive

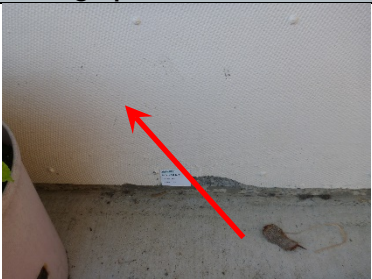
Identification		Location		Hazard Identification			Photograph
S101278	Building	1-4	Hazard Group	Asbestos	Laboratory Sample number	7 Cert No: B-19-0254

Floor(s)	Ground	Area	>50m <sup>2</sup>	Sample result	Chrysotile (White asbestos), Amosite (Brown/Grey asbestos), Crocidolite (Blue asbestos)	
			Product Type	1			
	Nature of site	School	Extent of damage	1	Labelled?	No	
	Int/Ext	Exterior	Surface Treatment	1	Re-inspection date	TBA	
	Room	1-4	Potential to release fibres	3 - Low			
Location	North side of building - wall			Recommendation	Remove all cement sheeting and downpipes as Class B work in accordance with the Approved Code of Practice.  All panels that remain are to be kept painted and their existence noted on the school's management plan.		
Description	Cement Sheet

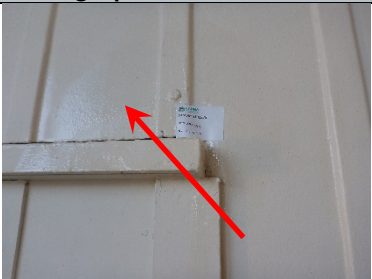
Identification	Location		Hazard Identification				Photograph
S101279	Building	1-4	Hazard Group	Asbestos	Laboratory Sample number	8 Cert No: B-19-0254

Floor(s)	Ground	Area	>50m <sup>2</sup>	Sample result	Chrysotile (White asbestos), Amosite (Brown/Grey asbestos), Crocidolite (Blue asbestos)	
			Product Type	1			
	Nature of site	School	Extent of damage	1	Labelled?	No	
	Int/Ext	Exterior	Surface Treatment	1	Re-inspection date	TBA	
	Room	1-4	Potential to release fibres	3 - Low			
Location	Located on east, south and west sides of building - walls			Recommendation	Remove all cement sheeting and downpipes as Class B work in accordance with the Approved Code of Practice.		
Description	'Coverline' profiled cement sheeting				All panels that remain are to be kept painted and their existence noted on the school's management plan.

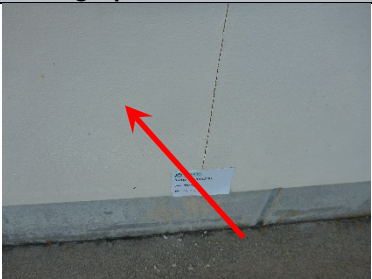
Identification		Location		Hazard Identification			Photograph
S101280	Building	1-4	Hazard Group	Asbestos	Laboratory Sample number	9 Cert No: B-19-0254

Floor(s)	Ground	Area	>50m <sup>2</sup>	Sample result	No asbestos detected	
	Nature of site	School	Product Type	N/A	Labelled?	N/A	
	Int/Ext	Exterior	Extent of damage	N/A	Re-inspection date	N/A	
	Room		Surface Treatment	N/A	Potential to release fibres	Nil	
Location	Located on all sides of building - walls			Recommendation	As there is a mix of asbestos and non-asbestos sheets attached to the building definitive confirmation is needed to confirm that any sheets do not contain asbestos if they are to be treated as non-containing.		
Description	Flat sheet

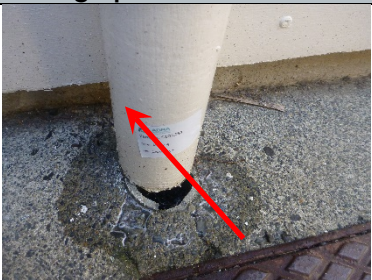
Identification		Location		Hazard Identification			Photograph
S101281	Building	1-4	Hazard Group	Asbestos	Laboratory Sample number	10 Cert No: B-19-0254

Floor(s)	Ground	Length	20m	Sample result	Chrysotile (White asbestos), Amosite (Brown/Grey asbestos), Crocidolite (Blue asbestos)	
			Product Type	1			
	Nature of site	School	Extent of damage	1	Labelled?	No	
	Int/Ext	Exterior	Surface Treatment	1	Re-inspection date	TBA	
	Room	1-4	Potential to release fibres	3 - Low			
Location	Around building			Recommendation	Remove all cement sheeting and downpipes as Class B work in accordance with the Approved Code of Practice.  All panels that remain are to be kept painted and their existence noted on the school's management plan.		
Description	Cement downpipes.  Note: <ul style="list-style-type: none"> <li>the pipe extends into the concrete, this detail will be replicated for all pipes on the site. Refer S101275.</li> <li>this particular pipe has been sheared at the base, remedial work is required to seal all the edges, a temporary PVA seal was placed at the sample location.</li> </ul>

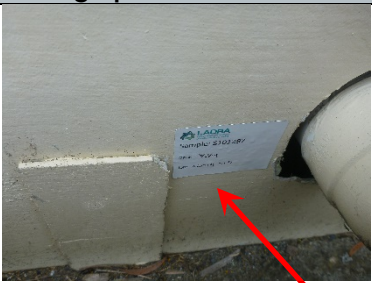
Identification		Location		Hazard Identification			Photograph
S101297	Building	9-12	Hazard Group	Asbestos	Laboratory Sample number	1 Cert No: B-19-0391

Floor(s)	Ground	Area	>100m <sup>2</sup>	Sample result	No asbestos detected	
			Product Type	N/A			
	Nature of site	School	Extent of damage	N/A	Labelled?	N/A	
	Int/Ext	Exterior	Surface Treatment	N/A	Re-inspection date	N/A	
Room		Potential to release fibres	Nil				
Location	Baseboard, room 11 entrance			Recommendation	N/A		
Description	Cement sheeting

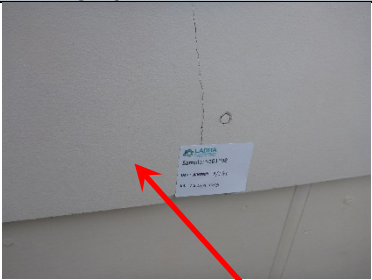
Identification		Location		Hazard Identification			Photograph
S101298	Building	9-12	Hazard Group	Asbestos	Laboratory Sample number	2 Cert No: B-19-0391

Floor(s)	Ground	Area	>100m <sup>2</sup>	Sample result	No asbestos detected	
			Product Type	N/A			
	Nature of site	School	Extent of damage	N/A	Labelled?	N/A	
	Int/Ext	Exterior	Surface Treatment	N/A	Re-inspection date	N/A	
Room		Potential to release fibres	Nil				
Location	Wall cladding, room 11 entrance			Recommendation			
Description	Cement sheeting

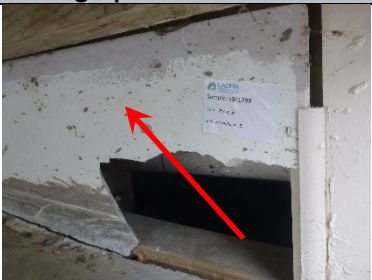
Identification		Location		Hazard Identification			Photograph
S101299	Building	9-12	Hazard Group	Asbestos	Laboratory Sample number	3 Cert No: B-19-0391

Floor(s)	Ground	Area	>100m <sup>2</sup>	Sample result	No asbestos detected	
			Product Type	N/A			
	Nature of site	School	Extent of damage	N/A	Labelled?	N/A	
	Int/Ext	Exterior	Surface Treatment	N/A	Re-inspection date	N/A	
Room		Potential to release fibres	Nil				
Location	Baseboard room 12 entrance			Recommendation	N/A		
Description	Cement sheeting

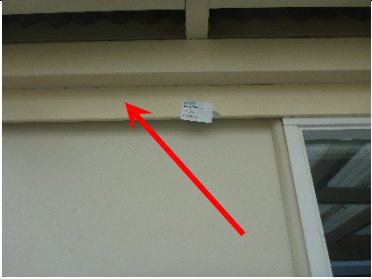
Identification		Location		Hazard Identification			Photograph
S101300	Building	9-12	Hazard Group	Asbestos	Laboratory Sample number	4 Cert No: B-19-0391

Floor(s)	Ground	Area	>100m <sup>2</sup>	Sample result	No asbestos detected	
			Product Type	N/A			
	Nature of site	School	Extent of damage	N/A	Labelled?	N/A	
	Int/Ext	Exterior	Surface Treatment	N/A	Re-inspection date	N/A	
Room	12	Potential to release fibres	Nil				
Location	Gable end, Galaxy Drive end of building			Recommendation	N/A		
Description	Cement sheeting

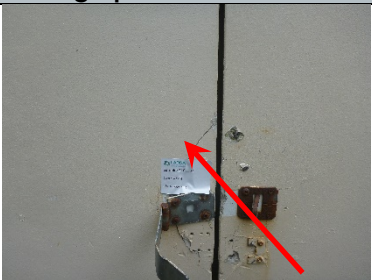
Identification		Location		Hazard Identification			Photograph
S101301	Building	9-12	Hazard Group	Asbestos	Laboratory Sample number	5 Cert No: B-19-0391

Floor(s)	Ground	Area	>100m <sup>2</sup>	Sample result	No asbestos detected	
	Nature of site	School	Product Type	N/A	Labelled?	N/A	
	Int/Ext	Exterior	Extent of damage	N/A	Re-inspection date	N/A	
	Room	10	Surface Treatment	N/A	Potential to release fibres	Nil	
Location	Underfloor wall cladding, back of room 10			Recommendation	N/A		
Description

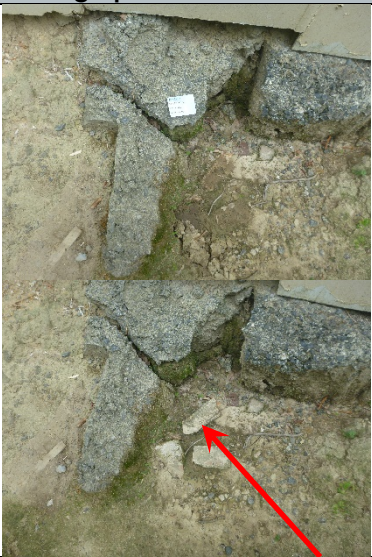
Identification		Location		Hazard Identification			Photograph
S101302	Building	9-12	Hazard Group	Asbestos	Laboratory Sample number	6 Cert No: B-19-0391

Floor(s)	Ground	Area	unknown	Sample result	Chrysotile (White asbestos)	
			Product Type	1			
	Nature of site	School	Extent of damage	2	Labelled?	No	
	Int/Ext	Exterior	Surface Treatment	1	Re-inspection date	TBA	
Room		Potential to release fibres	4 - Low				
Location	Rear of room 10			Recommendation	Remove all broken pieces of asbestos cement sheeting as Class B work in accordance with the Approved Code of Practice. It is recommended that the soil is assessed to determine there are no buried remnants of this material.		
Description	Broken cement sheet on ground				<p>Note: Access to the underfloor area of Rooms 9 to 12 was not possible, it is highly likely that more of this material will be located under these Rooms.</p>

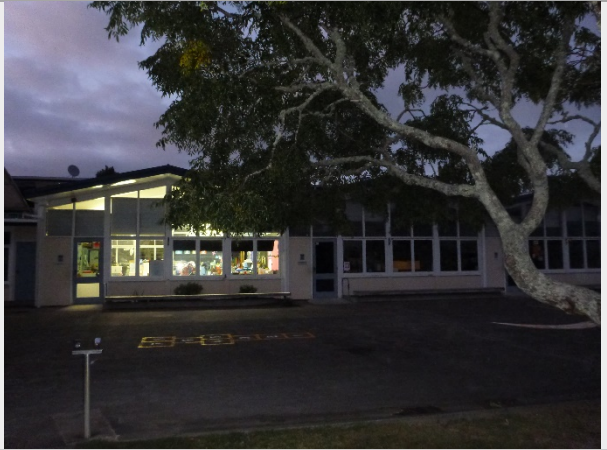
<p>View of Rooms 5 to 8</p> <p>Note:</p> <ul style="list-style-type: none"> <li>• timber joinery</li> <li>• flat sheet asbestos cement soffits and wall cladding under windows</li> </ul>

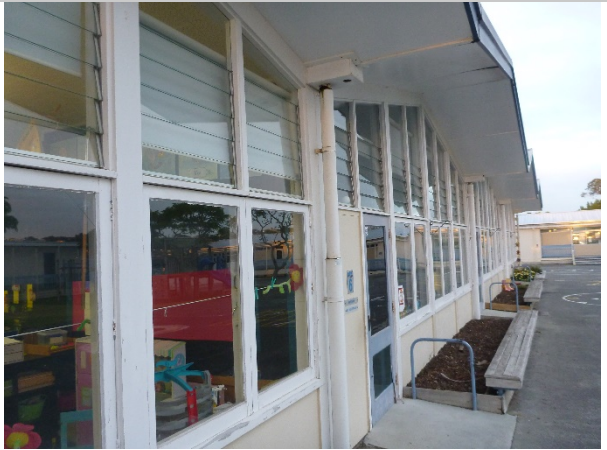
<p>View of Rooms 1 to 4 - ground floor</p> <p>Note:</p> <ul style="list-style-type: none"> <li>• Second level (Classrooms 16 to 19) is a totally separate building, and supported by external steel (grey) columns.</li> <li>• Second level not subject to survey</li> <li>• Rooms 1 to 4 are identical to Rooms 5 to 8.</li> </ul>

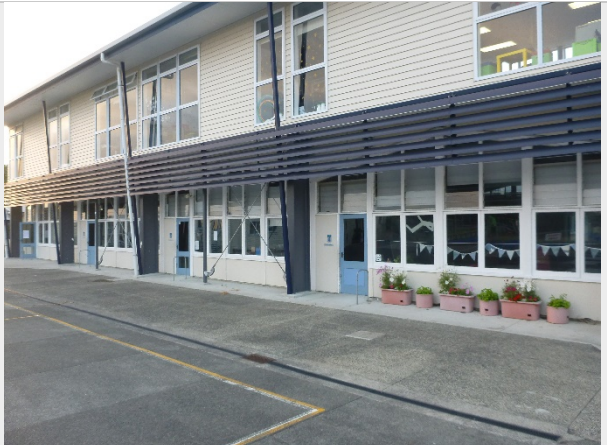
Description - Rooms 1 to 8	Photograph
<p>View of interface between the building located above Rooms 1 to 4.</p> <p>Note:</p> <ul style="list-style-type: none"> <li>Original roof line of Rooms 1 to 4 remains, infill area covered with cement sheeting. This sheeting was not accessed.</li> </ul>
